MSC-07007

APOLLO 16

30-DAY FAILURE AND ANOMALY LISTING REPORT

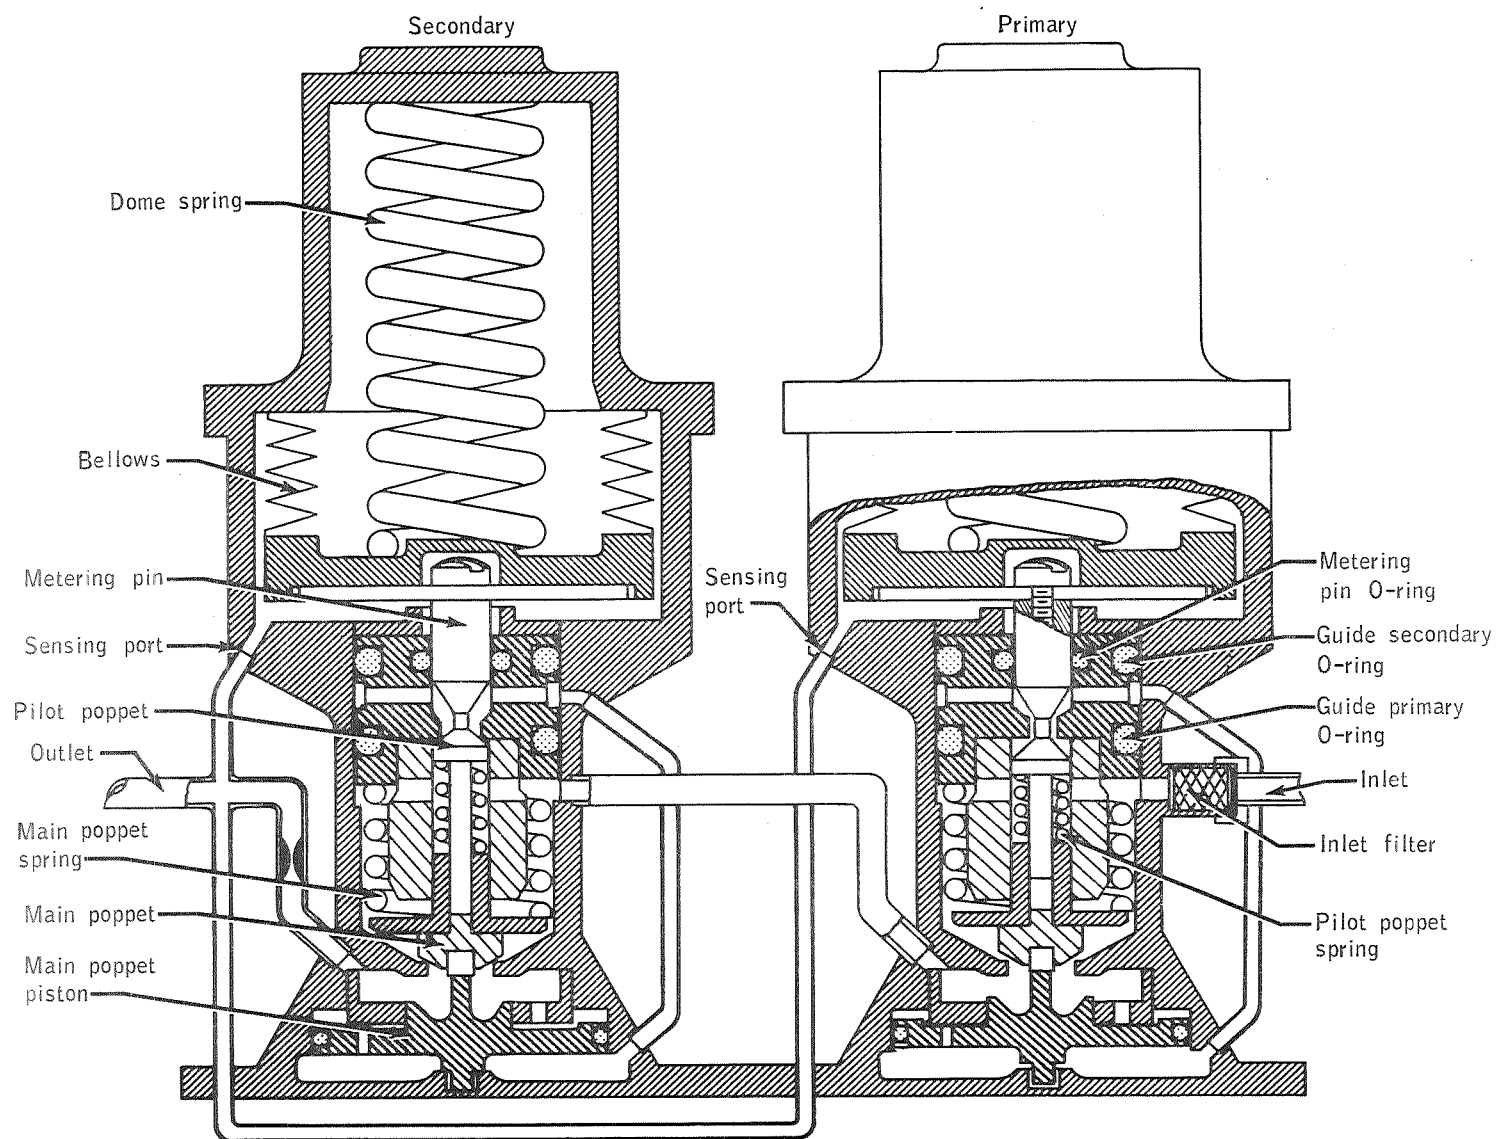
Figure 3-10.- Lunar module reaction control system pressure regulator assembly.

The helium regulator assembly consists of two series regulators (figure 3-10). The unit immediately exposed to the high pressure source is designated as the primary regulator and the downstream unit as the secondary regulator. Both units are identical in configuration with the exception of shims which are used to determine their pressure settings. The primary unit is set to regulate at 181 ± 3 psia; the secondary, at 185 ± 3 psia.

As was mentioned previously, the data indicated that the regulator malfunction was an internal leak beyond specification limits. (Specification value is 20 scc/hr). In order for the leakage through the total assembly to take place, a double failure within the assembly must exist. The matrix of the possible leakage paths is shown in table I. As can be seen from the matrix, there are 15 possible double-failure combinations which can result in the anomalous condition observed during the flight. Of these possible combinations, the four involving only the poppets are deemed the most probable. This is based on the fact that the leakage was variable, indicating a variation in the leakage path. A variable leak path is usually associated with the presence of particulate contamination rather than a damaged O-ring. This supposition is also supported by the fact that all O-rings which could have caused the anomaly were verified to be leak-tight during Kennedy Space Center checkout. The particulate contamination on the other hand could have been inside the regulator assembly during ground tests, but located in such a manner that it was not dislodged by the gas flow under 1-g conditions. In a weightless condition, however, the contamination could have been moved by the gas flow and deposited between any of the poppets and their seats.

It is also possible that, upon system activation, the initial pressure surge through the regulator inlet filter caused filter damage, thereby introducing particulate contamination into the regulator assembly. The flow of the pressurant gas through the regulator during the mission could cause the minute particles to move to and from the poppet seat areas, a condition which would cause a change in the leak paths and the ensuing leakage rates.

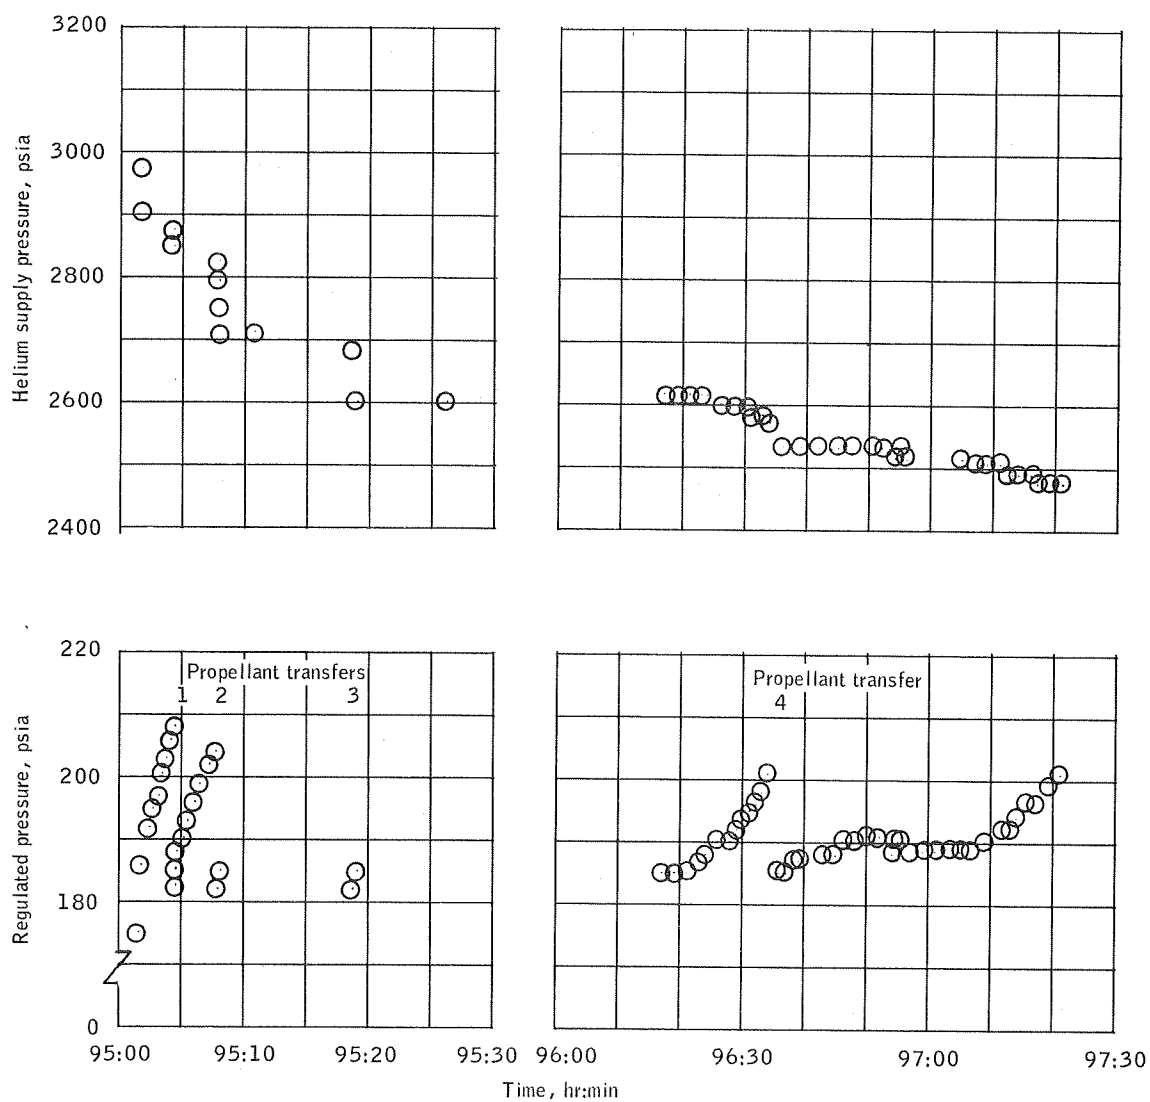
Figure 3-11.- Comparison of helium supply pressure and regulator outlet pressure following reaction control system pressurization.

Approximately 3 minutes after pressurization, the first of four propellant transfer operations was performed (fig. 3-11). The propellant transfer operations were performed not only to lower the ullage pressure, but also to create a larger pressurant volume in the propellant tanks, thereby obtaining a blowdown capability for expulsion of the remaining propellant in case of the total loss of system A pressurization gas through the relief valves.

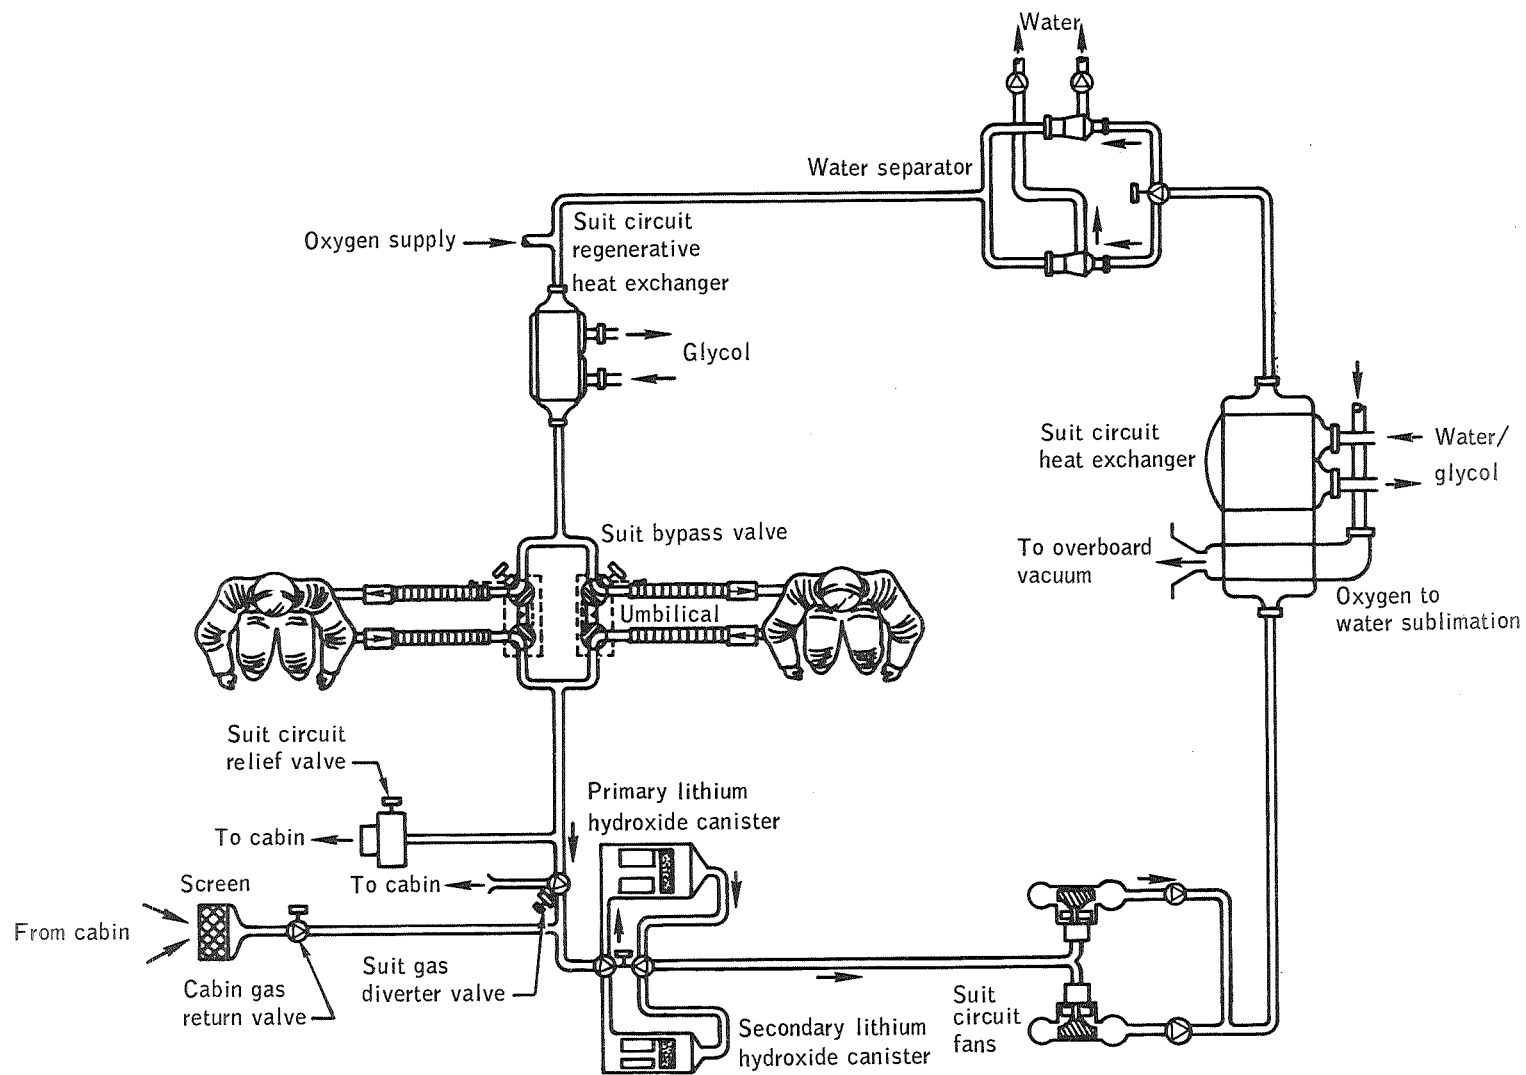
Figure 3-12.- Atmosphere revitalization section.

The crew reported hearing a chattering noise and experiencing a pulsating, insufficient flow in the suit circuit at 95:47 while configured to the cabin mode of operation (fig. 3-12). Data indicate that the cabin mode flow was normal at system activation (93:41), and this was confirmed by the crew after the mission. The pulsing and chattering occurred again after the demand regulator check (95:55) and after lunar landing (105:57).

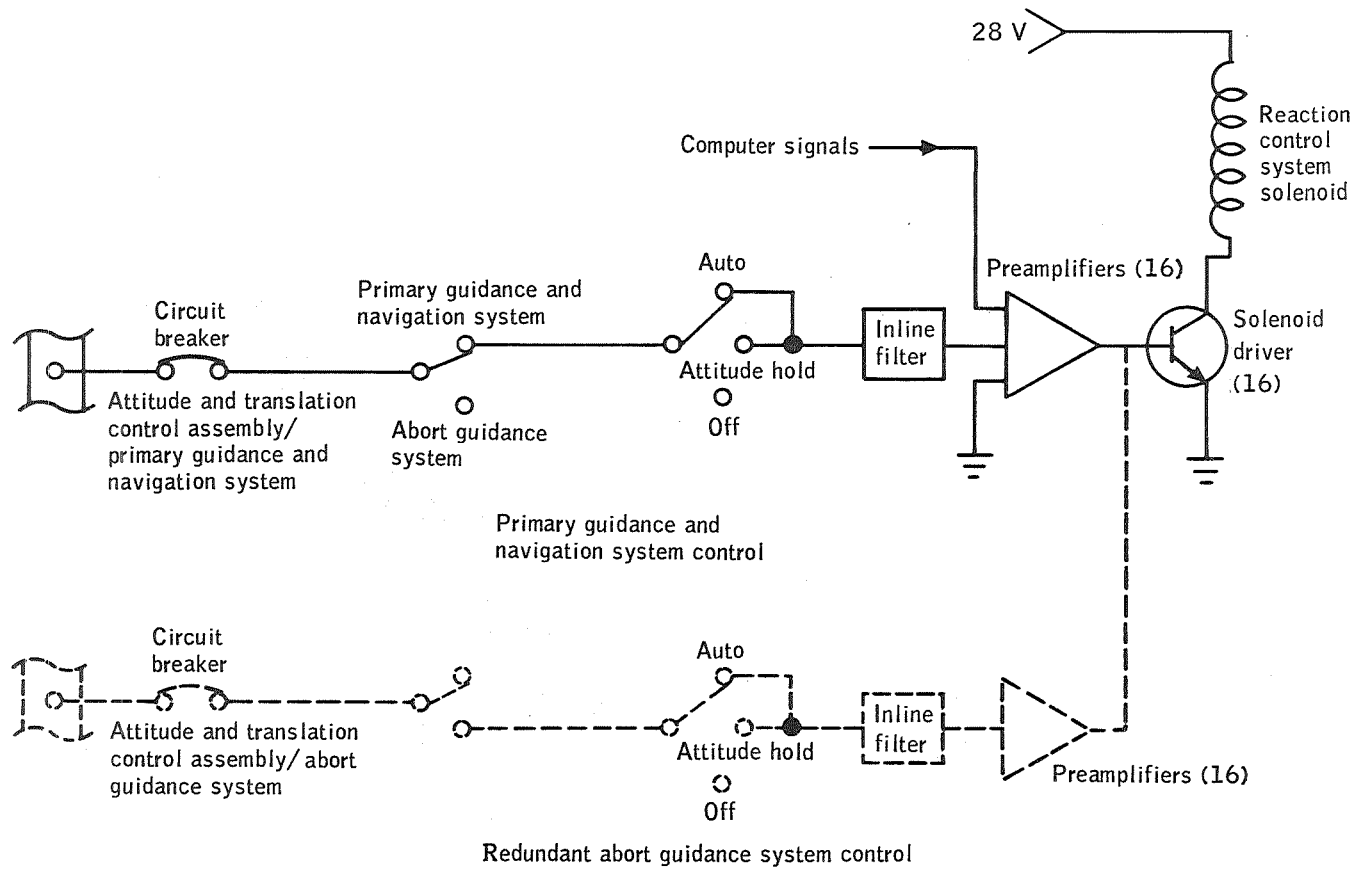
Figure 3-14.- Reaction control system control schematic.

Any of the following conditions could have caused the problem (refer to fig. 3-14):

- a. The circuit breaker which provides the 28-volt-dc enabling voltage to the primary preamplifiers may have closed mechanically but not electrically.

- b. The guidance control switch may have failed.
- c. The primary guidance mode control switch may have failed.
- d. The in-line filter could have failed.
- e. An open or short-to-ground may have occurred in the spacecraft wiring or associated connectors.
- f. The circuit breaker may have opened because of current loads in excess of 2 amperes.
- g. The circuit breaker could have been left open by the crew.

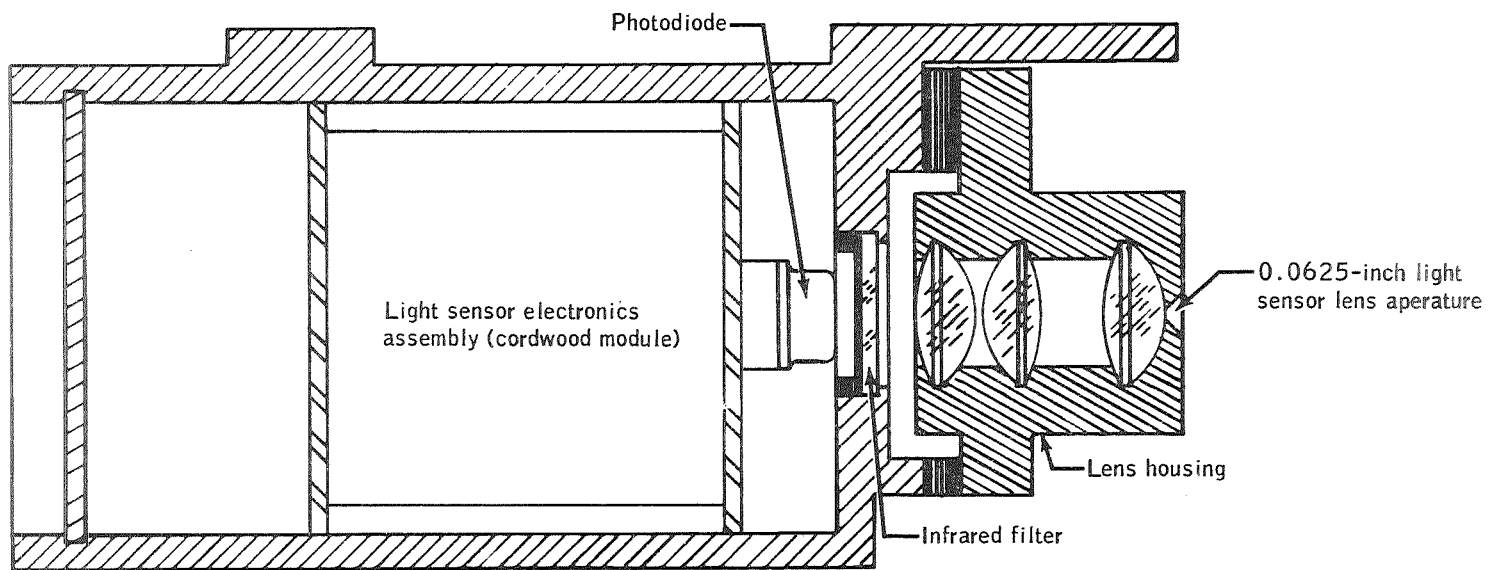
Figure 6-5.- Panoramic camera light sensor assembly.

Preliminary analysis indicates that the problem was, most likely, the result of a failure within the light sensor or its circuitry (fig. 6-5). Breadboard tests are being conducted in an effort to isolate the failure and prelaunch data are being reviewed to determine if the problem could have occurred prior to flight.
